**NO NAME 587 DAM
WASHINGTON COUNTY, MISSOURI
MO 30753**

**PHASE 1 INSPECTION REPORT
NATIONAL DAM SAFETY PROGRAM**

PHASE I INSPECTION REPORT
NATIONAL DAM SAFETY PROGRAM

PREPARED BY
INTERNATIONAL ENGINEERING COMPANY, INC.
CONSULTING ENGINEERS
SAN FRANCISCO, CALIFORNIA

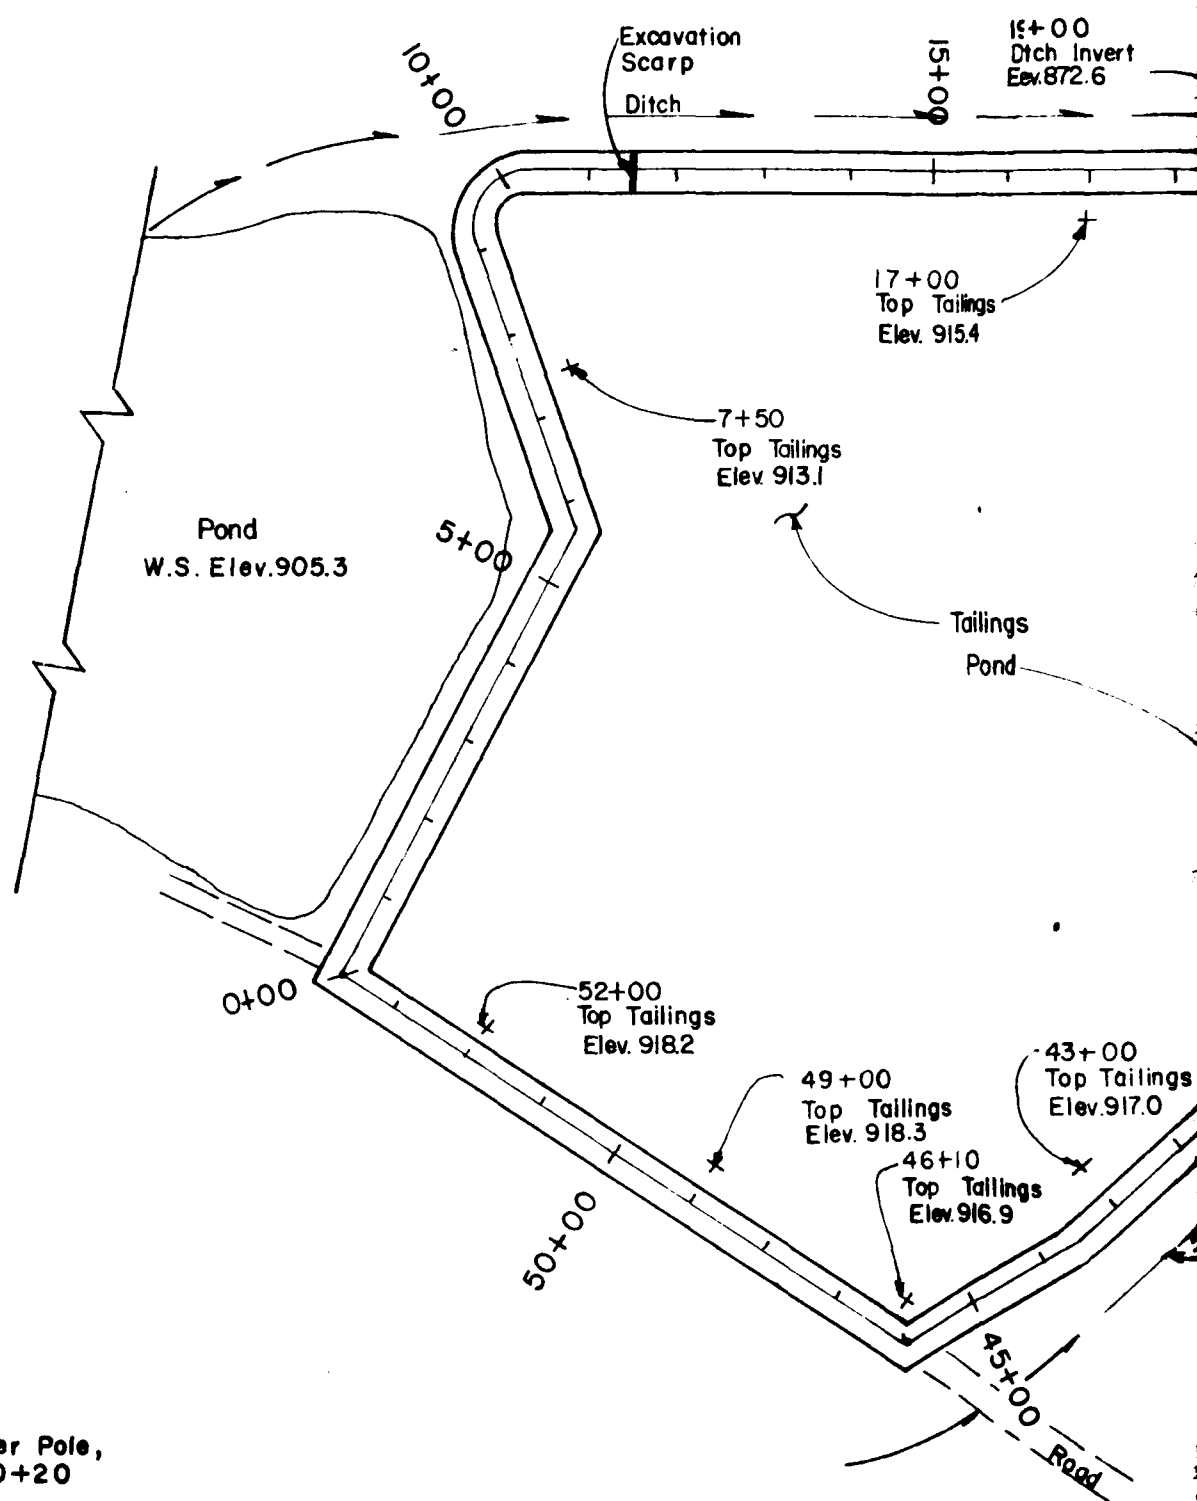
A seep is located at the toe of the dam at the north side of the impoundment at Station 21+80 (see Plate 3). The flow rate was estimated to be about 1 to 2 gpm and the water was clear. The soil at the location of the seep is very soft. Loose silt appears to have been deposited at the seep; this suggests that piping may have occurred and may still be occurring to some extent.
